MARITIME HERITAGE MINNESOTA

Phase I Archaeological Reconnaissance of the Big Island Steamboat Pier, Park, and Veterans Camp Site (21-HE-402) Project Report

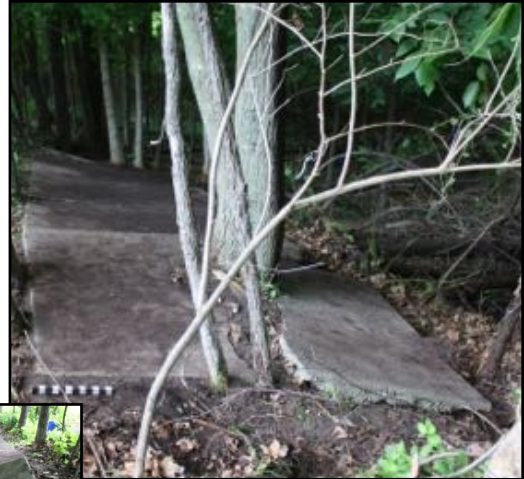
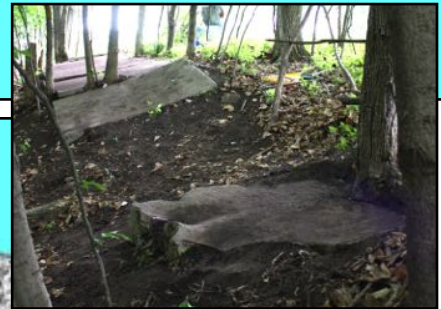
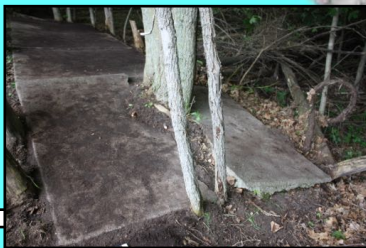
sections 5 and 6. North of the RDP Entrance Pavement, the RDP Foundation Block is found, not *in situ*. Lastly, MHM does not know when the BIAP Refreshment and Dance Pavilion was torn down. However, an undated image of the Water Tower clearly depicts The Mall as overgrown and un-groomed, indicating the image was taken between 1912-1918. Importantly, in this image, the Refreshment and Dance Pavilion's northwest corner was intact at that time. The building itself cannot be seen in some historical aerial photographs, but often the RDP Entrance Pavement and the outline of Restaurant/DancePavilion is clearly discernible in several images from 1956, 1960, and 1967 (John R. Borchert Map Library, 1956, 1960, 1967).

3D scans and photographic views of the Refreshments and Dance Pavilion (MHM).

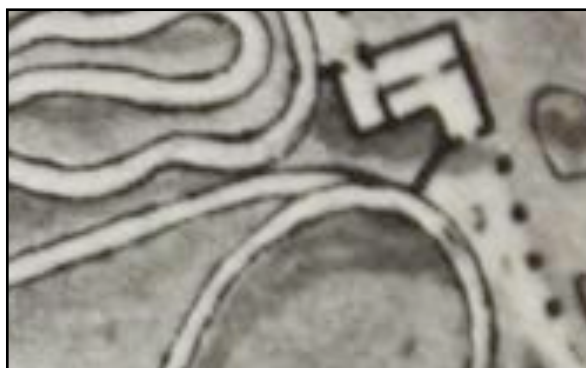
Left: Toilet 3 is seen as the L-shaped building and the row of Archways (Feature A8) shown as dots is heading to the west (Buffington 1906).

Right: Looking toward the northwest, this image is the only photograph MHM has located to date that depicts definitively Toilet 3 (ELMHS).

Since Feature T3 is clearly associated with the BIAP Mission Revival Archways: East-West, the BIAP Toilet 3's construction was likely integrated into that of the Archways. It is possible that the roof of the building may have extended to the Archways and provided a covered walkway for this section of the park. MHM cleared the northeast corner of the toilet building and exposed the wall sections and holes formed out of the concrete that secured sewer pipes where toilets or sinks would have rested. The outer

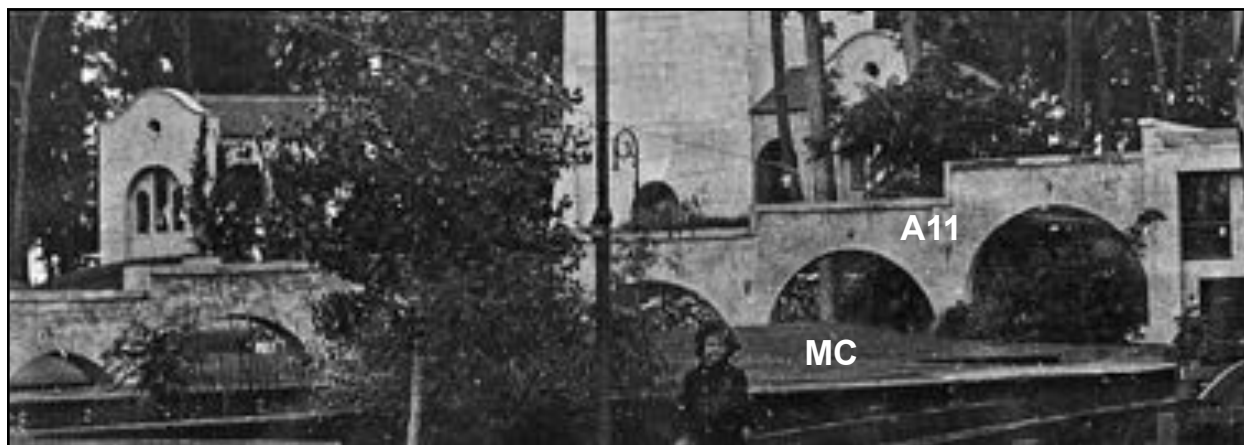
MHM has been studying the BIAP Mystic Chute as an earthenwork in the woods on Big Island since 2003. An obvious concrete wall running north to south, situated immediately to the east of the Refreshment and Dance Pavilion, is the base of a row of Archways (A11) that may have also served as the 'wall' of the Chute; its missing arch 'scars' are obvious. The twists and turns of the water ride are evident when the woods are thinned out. MHM has contended the Mystic Chute (labeled the Old Mill Ride on the Sanborn Map) was similar to the Ye Old Mill operating at the Minnesota State Fair since 1915.¹² Ye Old Mill was constructed as a winding concrete covered 'river' - a tunnel - that small wooden boats navigated for a short ride. A rare post card - and data accumulated during the 2019 BI Project - confirmed MHM's hypothesis. During this project, MHM surface-cleaned the areas on both sides of the concrete wall and used small test trenches further to the north to confirm the continuation of the wall toward Feature T3 - and 1 Archway Base survives further toward the T3 stairs. MHM estimated the width of the concrete 'river' and a small test trench opposite of the first small trenches confirmed the hypothesis - the other side of the Chute was located. The width of the boat ride channel varied from 8.50' to 9.00' to 10.00', measured at various locations along the earthenworks and the exposed Archway Base. Further, MHM used a probe inside the Chute and after 36.00", a hard surface was reached. MHM contends the complete or nearly complete winding Chute may survive under the matrix, although root damage from large trees may have damage the structure. The Mystic Chute twists and turns are clearly seen in a 1962 aerial image. The section of the Mystic Chute near the end of the ride was raised off the ground - it resembled a roller coaster - and the boat splashed into a small pool before it turned to the east toward the off-loading area. The remnants of the small pool can be seen in 1937 and 1960 aerial images and a concrete support for this ride section is *in situ* (Mystic Chute Support). Lastly, on the west side of the Mystic Chute the remains of a small building (MC Outbuilding) were located; the foundation of the building had fallen down the earthenworks that encompass the Chute. It can be seen on the 1912 Sanborn Map. MHM 3D scanned the visible section of A11 and the Chute, and connected them to Toilet 3 (see above).

The series of Archways (A11) is seen above. Note the stepped nature of this series of arches as it traveled downhill. The Mystic Chute's winding 'roof' is labeled MC (ELMHS).

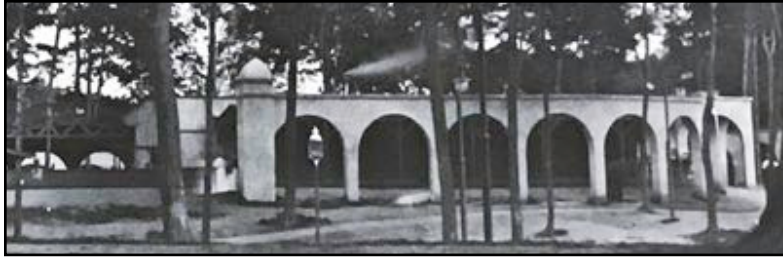
Left: These Mission Revival Archways represent the west side of the Amusements Building and surround the loading/unloading area. The white building attached at the back of the building is the loading dock for the Roller Coaster (see below, MNHS MH5.9ORr2).

Right: The outside contour line of the Mystic Chute's roofed channel and the pool are visible in this post card image taken from the Water Tower (Darel and LaVerna Leipold).

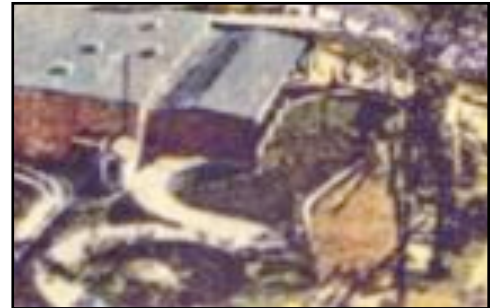
Left: The 'boat' on the Mystic Chute Ride is heading toward the pool and the last turn before it headed into the west side of the Amusements Building. The MC Outbuilding is seen under the track and the end of A11 is seen between the track and the Refreshments and Dance Pavilion (the pitched roof building to the left). The wood slatted 'barrier' seen to the right is the outside wall of the Chute's above ground 'tunnel'. The Mission Revival Archway with the small cap on top on the left of the image is the same one that is depicted in photo MNHS MH5.9ORr2 above (ELMHS).

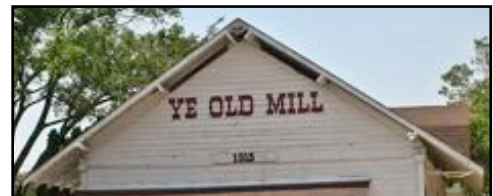
Below Left: The green 'tunnel' is Ye Old Mill at the Minnesota State Fair; its basic design matches the Mystic Chute (MHM).
Right: Ye Old Mill was established in 1915 and the aerial photograph clearly shows the above ground 'tunnel' that constitutes the ride (Ramsey County).

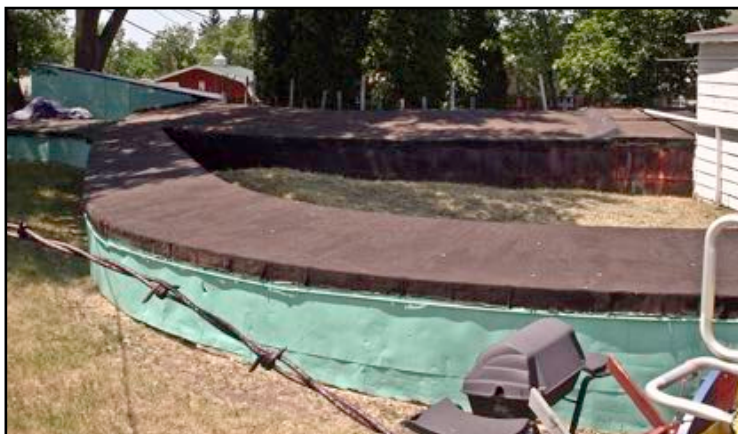
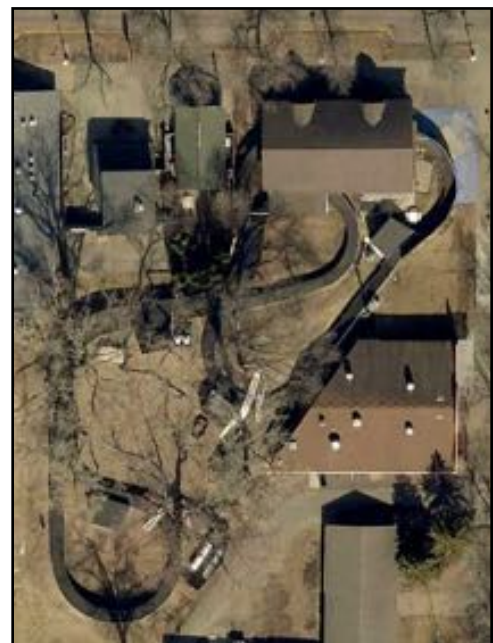
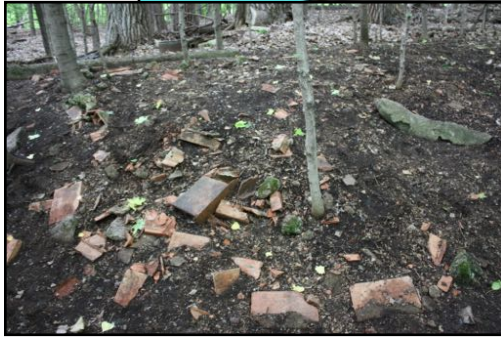
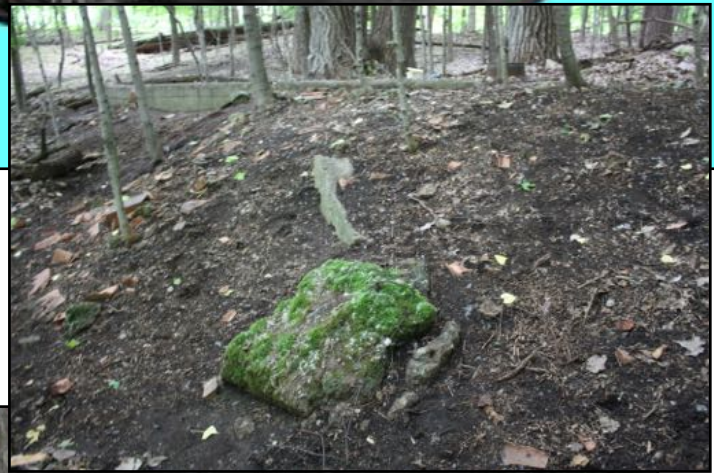
3D scans of the northwestern edge of the Mystic Chute/A11 and the small out-building that collapsed down the ridge (MHM).

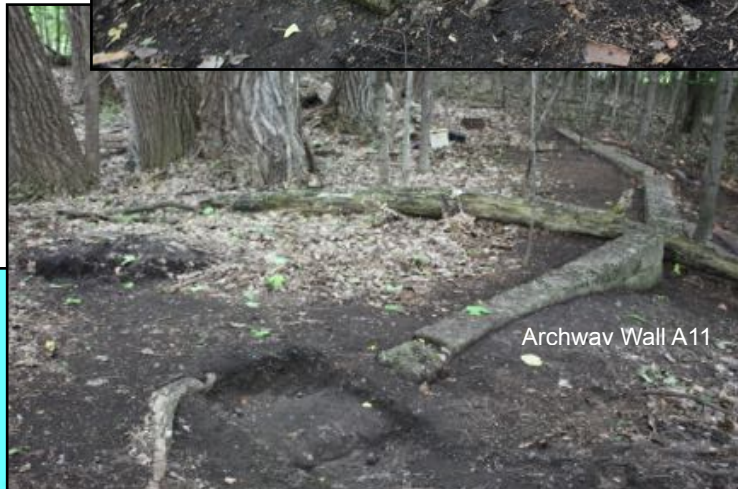
This end of Archway Wall A11 is seen in the image between the Refreshments and Dance Pavilion and the raised section of the Mystic Chute Ride.

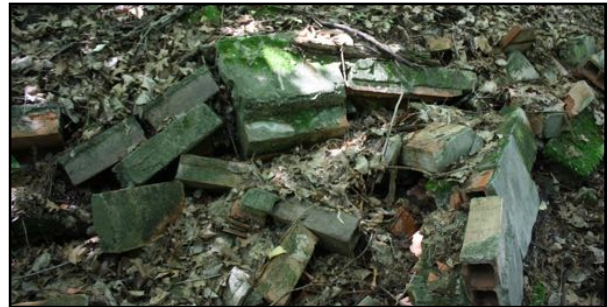
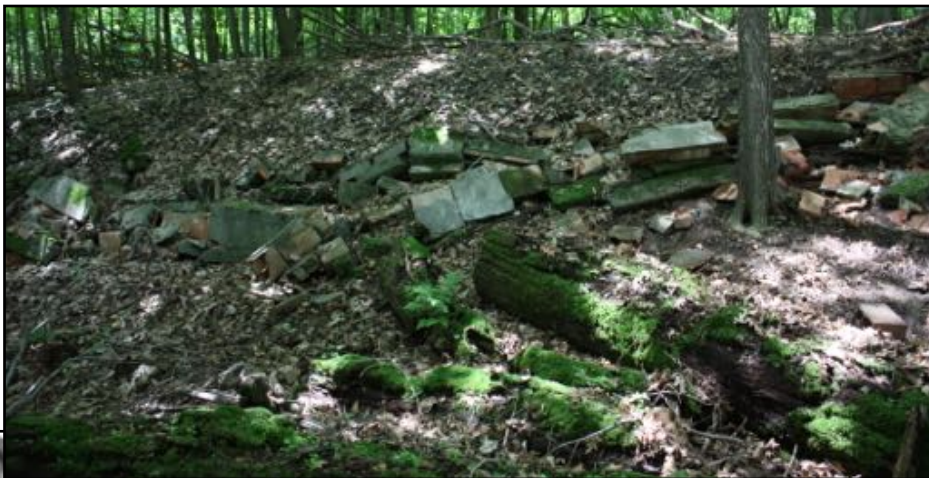
Above: The Figure Eight Roller Coaster diagram at the upper left as a rectangular support on its western side; MHM located the support in 2003, and documented/3D scanned it in 2019 (Sanborn Map Company, 1912).

Below: Feature A7, the North-South Archways, have collapsed into a gully to the west of the Roller Coaster; MHM 3D scanned some of the wall. Many parts of different Archways are extant, but currently only a toppled one is recognizable (right),

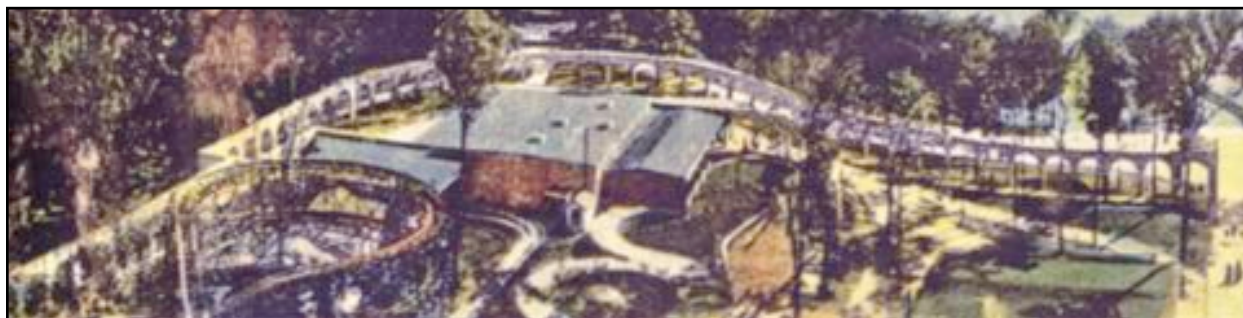
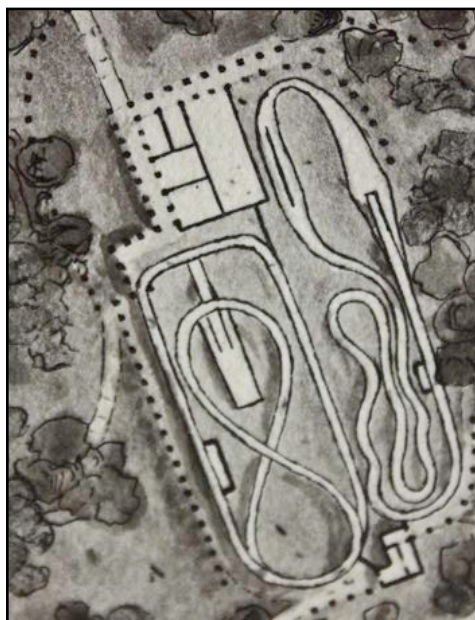
Above: The Amusements Building is the flat-roofed building at the 'top' of the image. Feature A7 - seen at the right side of the image - is the same structure discussed above in relation to the Figure Eight Roller Coaster. The Archways took a dog-leg and continued southward, curved around the Amusements Building and continued to the East Gazebo at the Landing. The loading/unloading building for the Roller Coaster can be seen attached to the north side of the Amusements Building, and the Mystic Chute's loading and unloading area is inside the west side addition to the building. The Amusements Building's Archway design allowed it to obscure some of the 'inner workings' of the rides. The above image is also helpful since it also depicts part of the roof of the Restaurant and Dance Pavilion, and it associates these major buildings and constructions with each other visually (Darel and LaVerna Leipold).

Left: A Buddington plan of the Amusement Rides area that supports the above image. While the plan is not entirely accurate, in consideration of many attributes, it is useful (Buddington 1906).

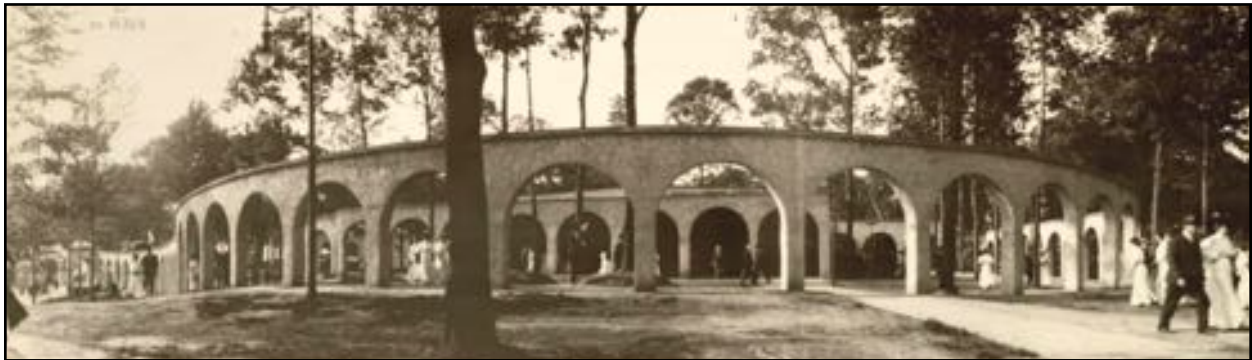
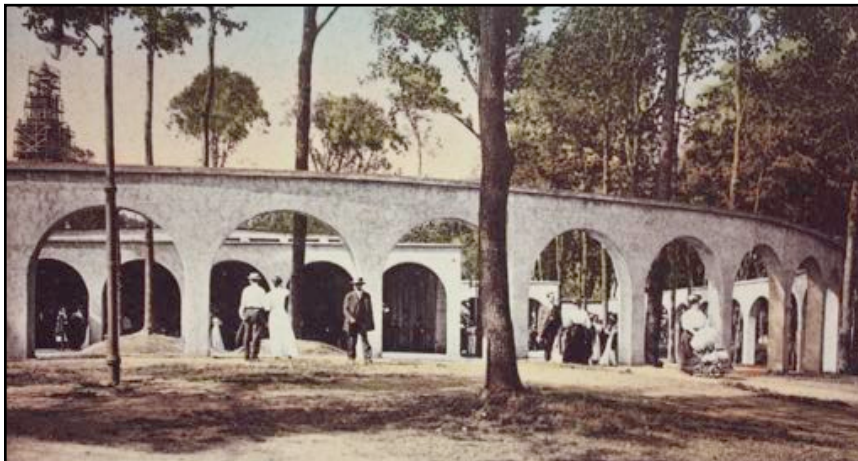
Left: The Amusements Building is the structure with the arched portico on the far side of Feature A7. Feature 7 is in the foreground and still under construction, like the Water Tower in the distance.

Below: Feature A7 as it curved around the Amusements Building and joined the East Gazebo at the Landing (Buffington 1906).

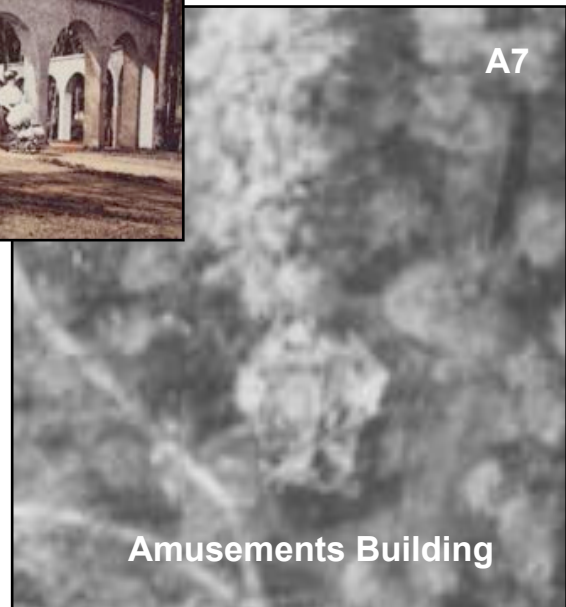
Above: Another view of Feature A7 as it curved around the Amusements Building; note the scaffolding around the unfinished Water Tower (ELMHS).

Right: The ruin of the Amusements Building in 1956 (John R. Borchert Map Library, 1956).

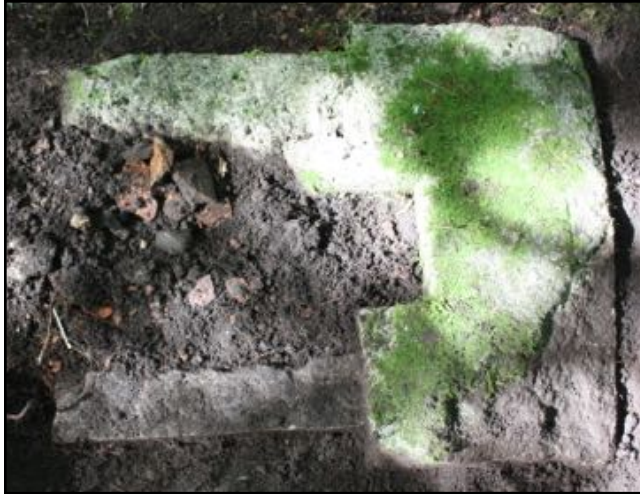
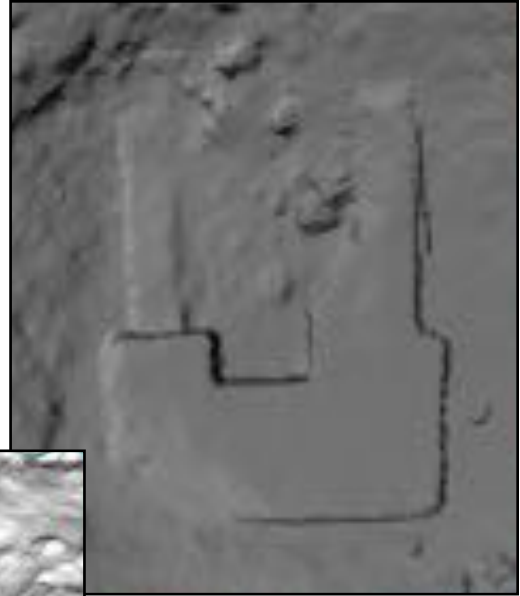
A photograph and 3D scans of the Mystic Chute Support (MHM).

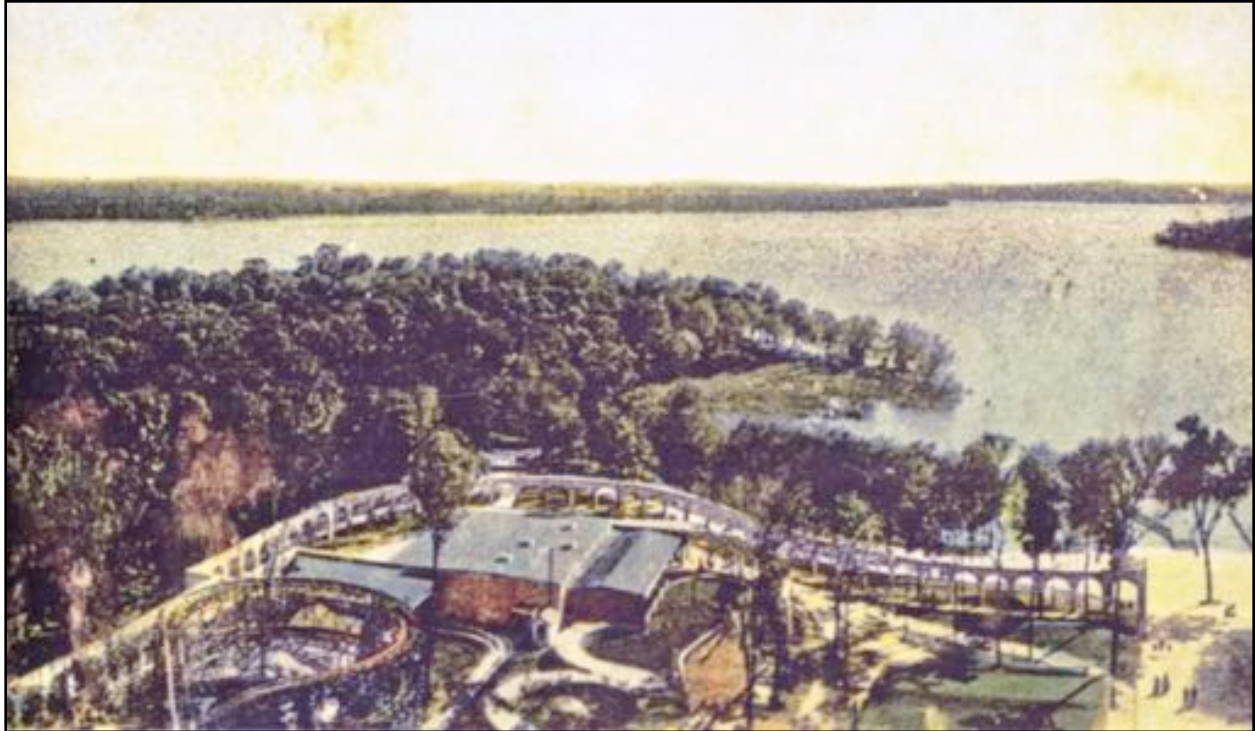
This complete view from the Water Tower pulls together the associations between the buildings, Archways, Gazebo, Landing, and Lake Minnetonka itself. This image is crucial to MHM's understanding of a substantial portion of the project area (Darel and LaVerna Leipold).

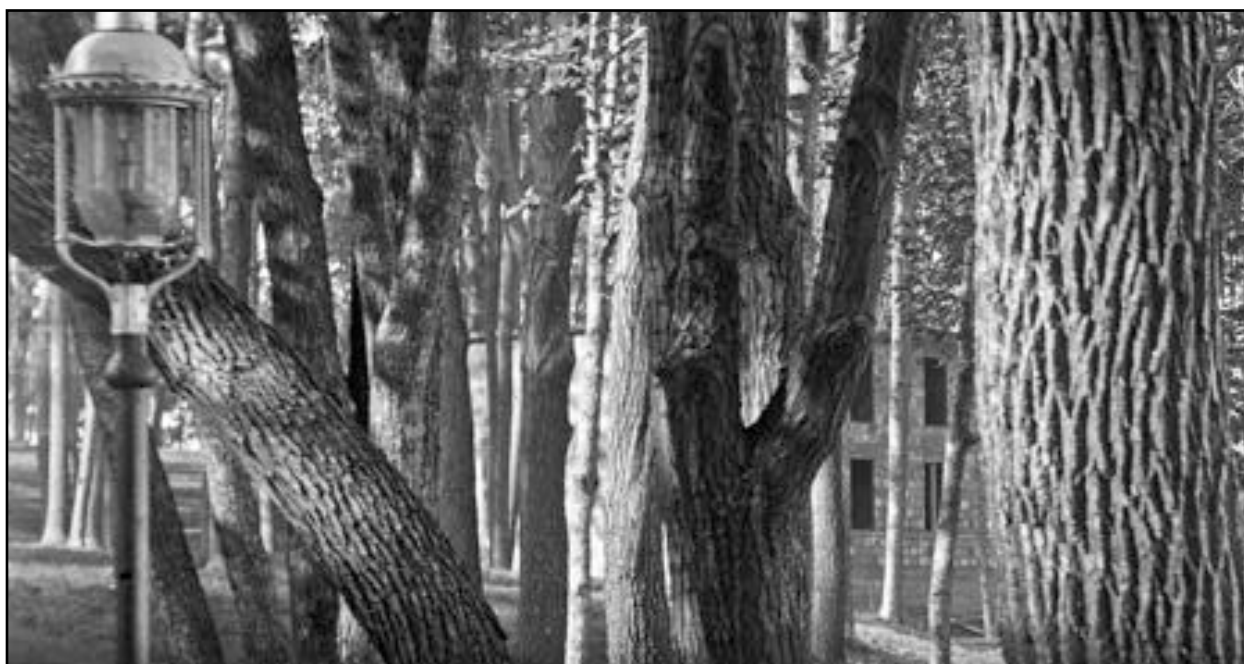
This obscured view of the Women's Dormitory is the only confirmed image of the building MHM could locate beyond some aerial views. Note the exposed terra cotta brickwork, an indication that either the building was still under construction (before 1906) or it had been abandoned (after 1912, EB05684, Edward A. Bromley Collection).

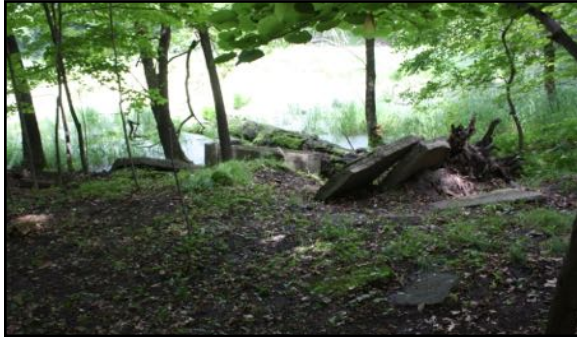
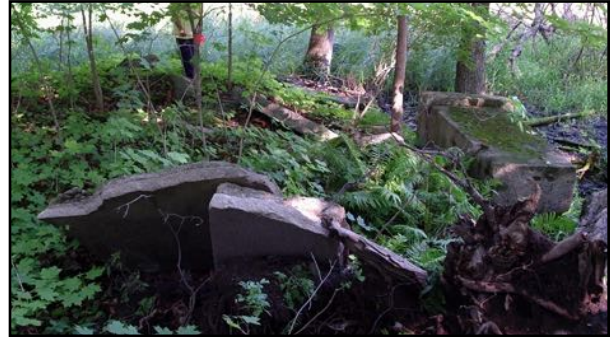
Questions about the large midden of concrete and terra cotta tile that comprise the Swamp Watching Platform remain unanswered (MHM).

Another obvious collection of concrete and terra cotta brick feature on Big Island is located on the lowest point on the island near the largest pond - the BIAP Swamp Watching Platform. MHM gave this feature a whimsical name because the purpose of this large toppled structure is completely unknown and yet, it was not dumped at its current location; most of it is *in situ*. Further, the area was lighted by tall lamps, indicating island visitors were encouraged to visit the Swamp in the evening. No aerial images of the area provide details of the feature. MHM 3D scanned the Swamp Watching Platform; it is hoped its purpose can be ascertained in the future.

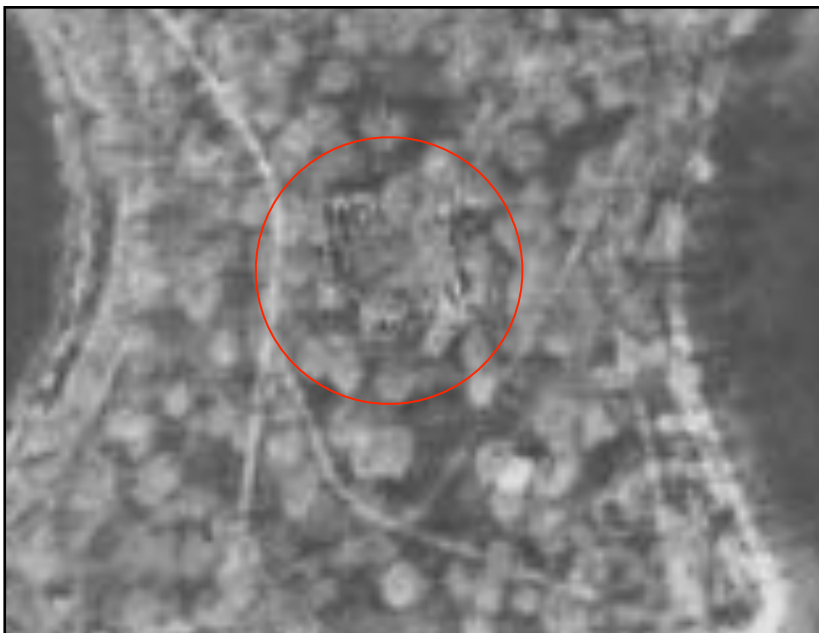
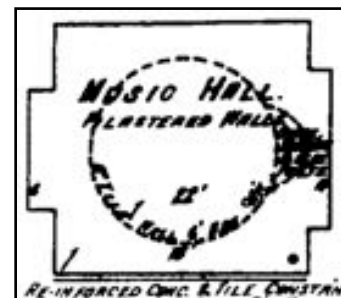
The Music Casino was a substantial ruin in 1956. Its shape is clearly seen in the aerial image when compared to its depiction in the Sanborn Map (John R. Borchert Map Library 1956; Sanborn Map Company 1912).

Initially, it was difficult to ascertain - archaeologically - where the Music Casino once stood, regardless of its large size. Studying aerial photographs allowed MHM to narrow down its precise location. While early images from 1937 depicted the Music Casino, the photographs lacked detail. To contrast, photographs taken on 7 May 1956 clearly show the ruins of the building, including Archways, porticoes, and the round auditorium. The next year the feature was evident in aerial photographs but with no detail, and by 1960, all Music Casino remains were entirely destroyed or buried. MHM began surface

cleaning an area where the west portico should be found - and its foundation was easily located less than an inch below the surface. Following the east portico foundation in both directions, MHM found that the Sanborn Map and Buffington's blueprints are accurate in the Music Casino's depiction. A series of small test trenches and simple surface cleaning in some areas allowed MHM to uncover the entire west portico, the remaining section of the west wall, and its turn to the east. The corner junction of the west and south walls is intact, as is most of the Archway wall foundation. MHM did not uncover the corner junction of the west and north walls or north and east walls, because of the great depth of the matrix in those areas. Further, the archaeological questions concerning the Music Casino were answered without deep test trenches or shovel tests. MHM 3D scanned the investigated areas, providing a good basis for future research should further investigation be warranted. See the appendix for larger versions of the 3D scanned Music Casino features.

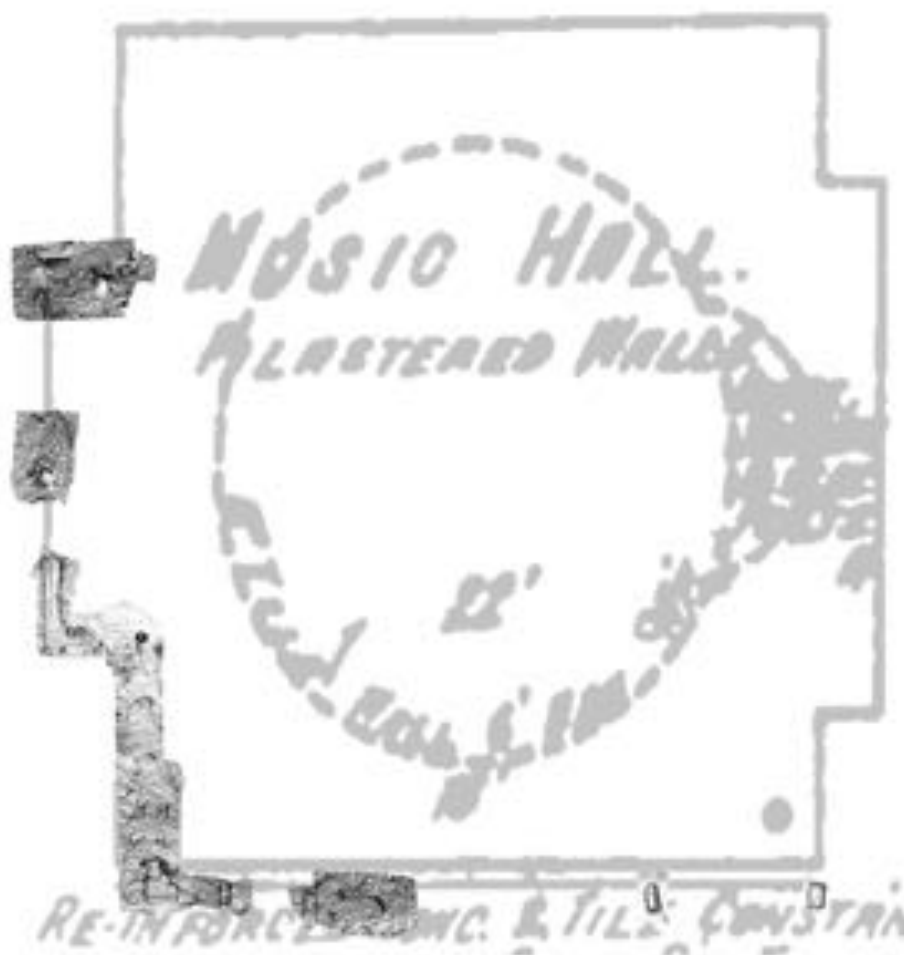
MHM uploaded the 3D scans of the Music Casino to test how accurate the system can be when dealing with a large feature. MHM is impressed with the output of the system. Note that the south wall does not follow the original, but it is accurate. Archaeological features do not always - actually, they usually do not - match a blueprint. Features shift, are moved around, are looted, are accidentally or intentionally destroyed - just about anything can happen to them (Sanborn Map Company 1912).

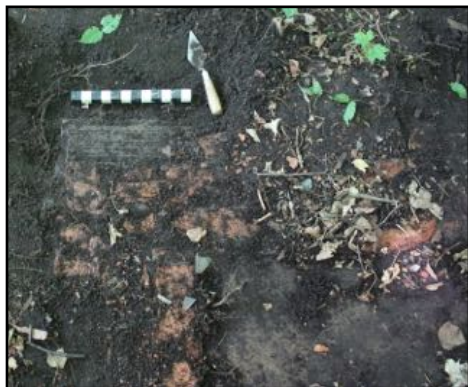
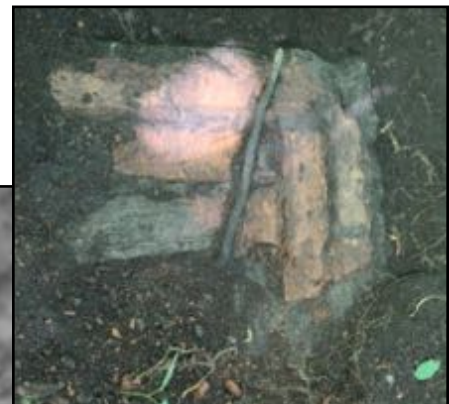
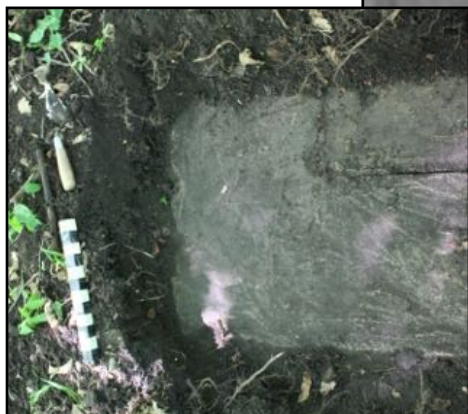
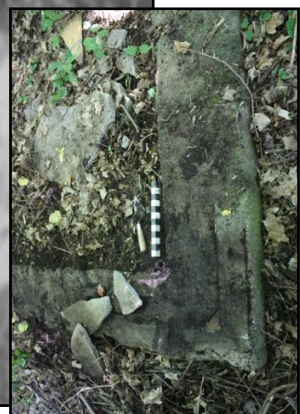
The 4 corners of the Electrical Substation and an aerial image of the feature in 1960 (John R. Borchert Map Library 1960).

To the southeast of the Music Hall, the BIAP Electrical Substation's rectangular foundation wall survives *in situ*. Further, through probing, MHM has determined much of the poured concrete floor is intact under the shallow matrix. The Electrical Substation is 28.00' by 34.00' in size and remnants of the walls indicate the building was constructed of terra cotta brick reinforced with concrete and adhered to each other with mortar. The Substation was vital for the operation of the BIAP's electrical equipment. The Electrical Substation housed transformers that would reduce the voltage the system received - 13,500 volts - to an appropriate level for the electrical systems on the island. Throughout BIAP, thousands of electric lights were strung through the trees, tall lamps were wired for light along walkways and outside buildings, and the Water Tower would light up in the darkness to be seen for several miles the: "wonderful pleasure resort will be brilliantly lighted with powerful electric lights. Night will be as bright as day". Further, part of the BIAP infrastructure included 700 and 800 HP electrical motors that were also served by the transformers in the Electrical Substation. The building received the system voltage through an underwater cable laid down to the island from Ferguson's Point and Deephaven to Hopkins and into Minneapolis. The generating station owned and operated by the TCRT in the city sent the current overland using power poles (*Minneapolis Journal* 1906). Aerial photographic evidence is helpful in determining when the BIAP Electrical Substation was no longer extant; an image from May 1960 clearly depicts the feature with a collapsed roof. By November 1967, the building's damaged walls still stood, and the main roof beam was in place; the remainder of the roof was gone. By November 1971, the rectangular foundation was protruding above the ground enough to be visible using aerial photography, but it was mostly destroyed (John R. Belchert Map Library 1960).

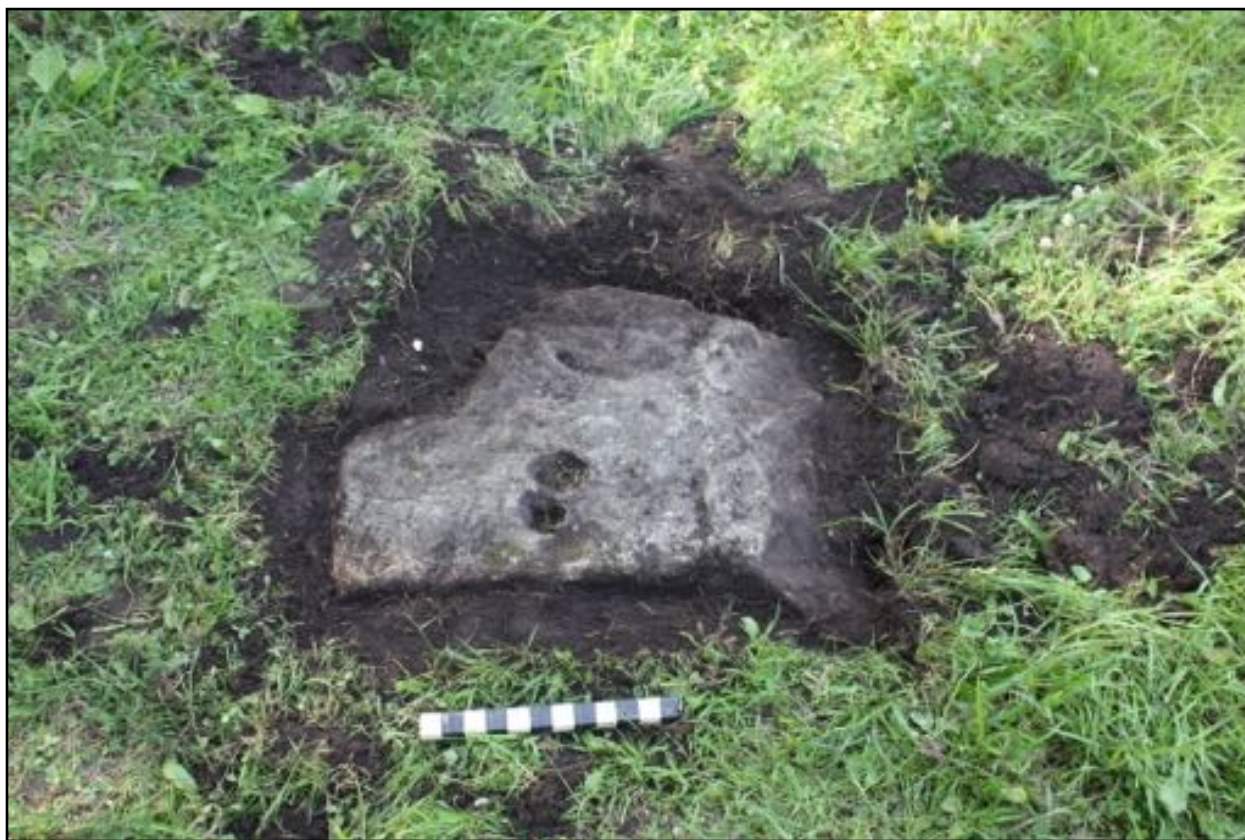
The BIAP Band Stand was a 1.5 story open wooden structure that measured 15.00' by 15.00'. MHM is not aware of any photographic images of the Band Stand, but it was depicted in BIAP promotional materials¹⁵. MHM located a small bit of physical evidence of the Band Stand in the form of an *in situ* concrete foundation with embedded metal pipe that may have been a conduit for electrical wires. Further, the Cabin Steps Midden may be related to the Band Stand (see below).

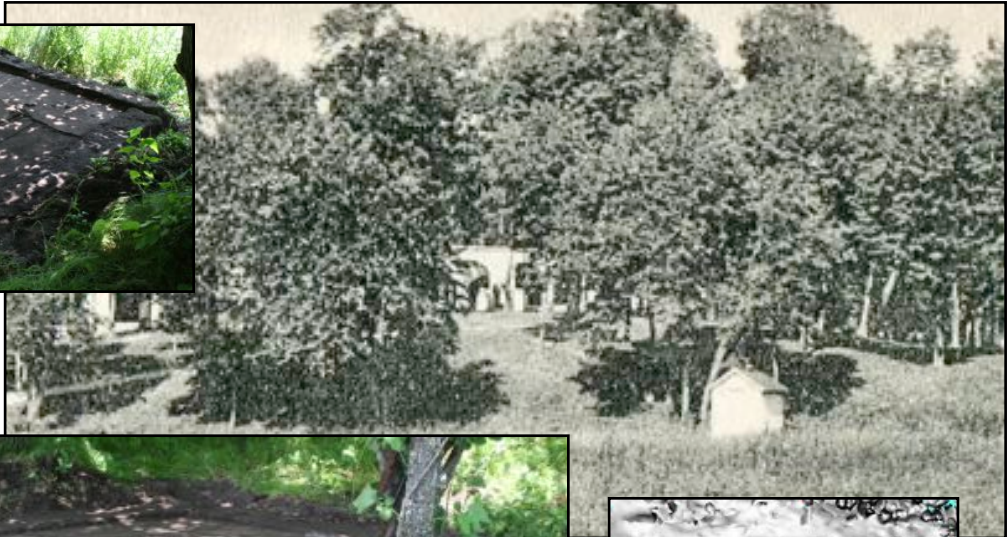
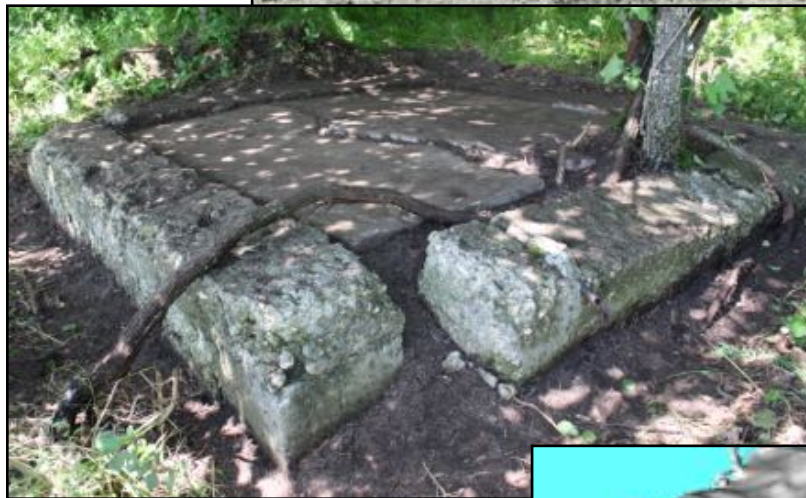
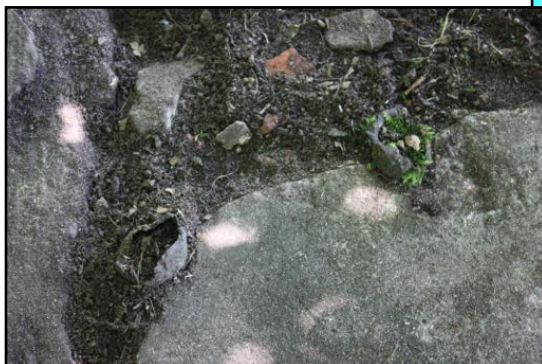
MHM located the BIAP Pump House near the shoreline. Surface cleaning revealed the intact - but cracked - concrete foundation and floor. Remnants of the terra cotta bricks that comprised the walls can be seen in the concrete and sherds of the bricks are scattered around foundation. A metal pipe for taking water out of the lake to be used on the island protrude from the south side of the foundation. Other pipes protrude from the concrete floor that would direct the water to the proper location in the BIAP. Originally the building measured 8.00' square, but tree roots have shifted the feature and its current size is 8.30' by 8.50'. MHM 3D scanned the Pump House remains.

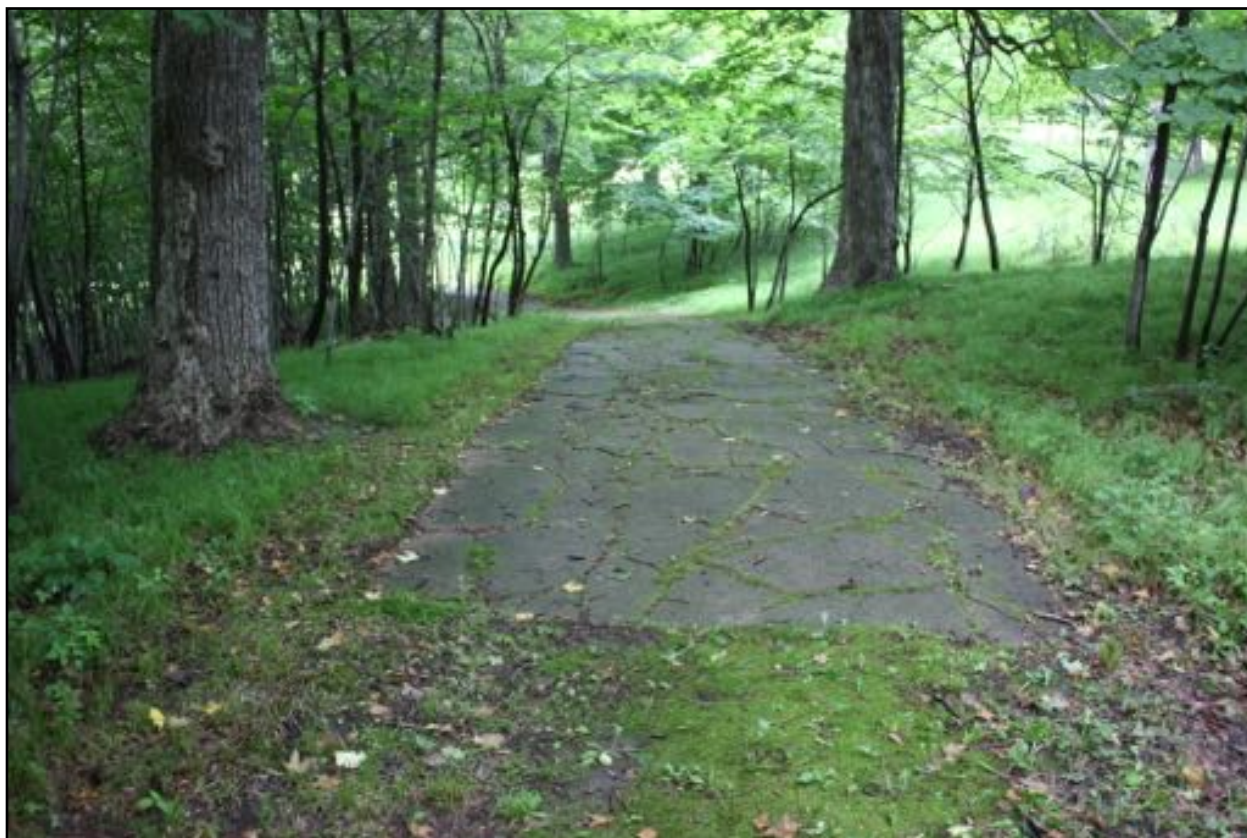
A BIAP Path made of concrete leads visitors eastward toward the attractions on Amusement Boulevard. The pavement survives but is cracked and worn.

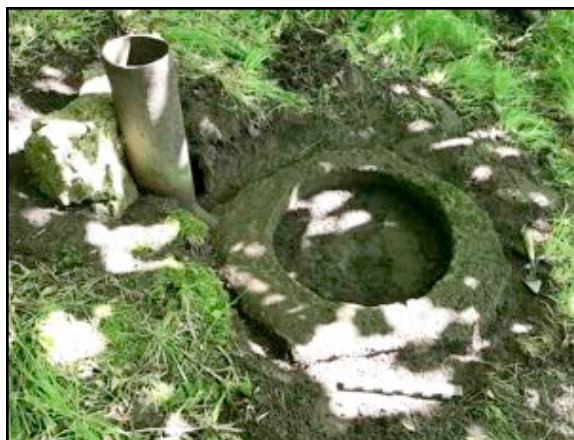
Lamp Base 23 (LB-23)

As shown in postcards and photographs, the BIAP was lit with thousands of lights, along with the Water Tower light. Some of the lights around the island were in the form of tall Lamp Posts and remnants of many of them survive around the project area. MHM located 35 Lamp Bases during the 2019 survey; some of them were filled with concrete and a metal pole by the BIVC and used as bases for camp grills. The Lamp Bases are in varying states of preservation and many are mostly buried in the matrix. MHM surface cleaned around LB10 (simple base), LB14 (re-used BIAP lamp base transformed into a BIVC grill base), LB23 (complete base), and 3D scanned those features as examples of the types of Lamp Bases still *in situ* in the project area. MHM is positive that more Lamp Bases survive undiscovered, particularly in The Mall area.

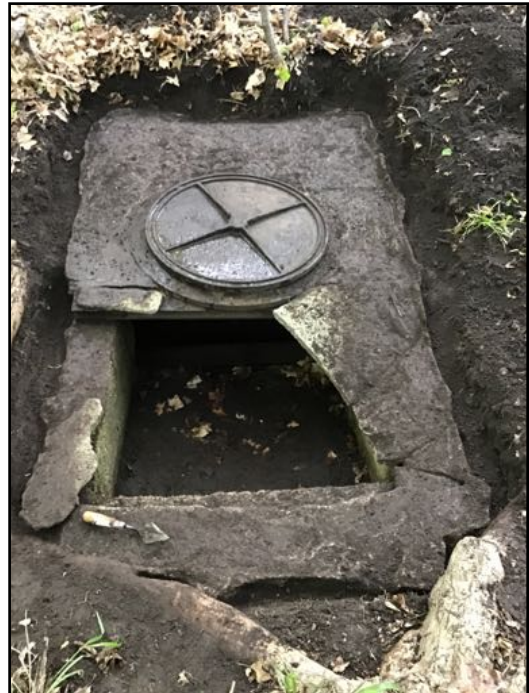
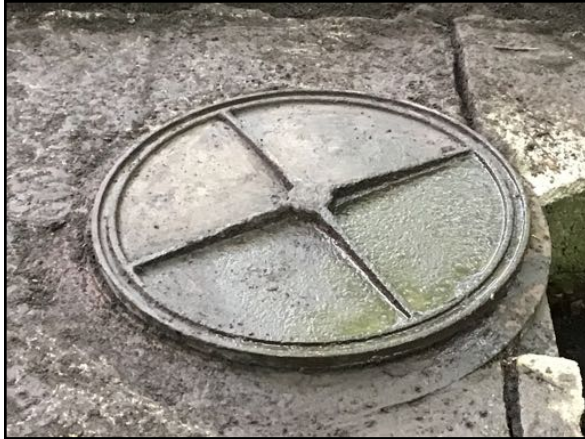
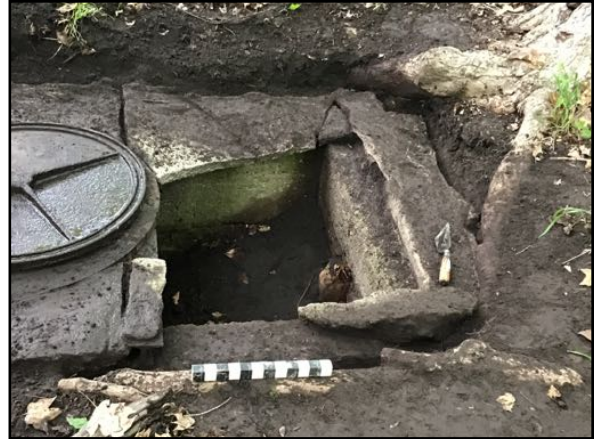
D11: Silt Trap

Six silt traps have been identified in the project area. Silt Trap D11 is the most intact example and MHM thoroughly documented the concrete, metal, and wooden feature, including 3D scanning. Based on the location of D11, it served the Music Casino's drainage needs.

During the fieldwork, MHM completely documented Silt Trap D11 - the most intact silt trap in the project area - and it was covered with branches to prevent people from falling into it. Five days later, MHM found the barrier removed and the broken concrete cover for the feature were tossed all over the area - we assume someone wanted a selfie inside the trap or they were looking for something they considered 'valuable'. Regardless, the care MHM took when documenting D11 inside and out, and the time taken not to disturb the broken cover, was wasted. For now, while MHM replaced the pieces where they 'should' be, they are not where they were when they were *in situ*, undisturbed since 1905.

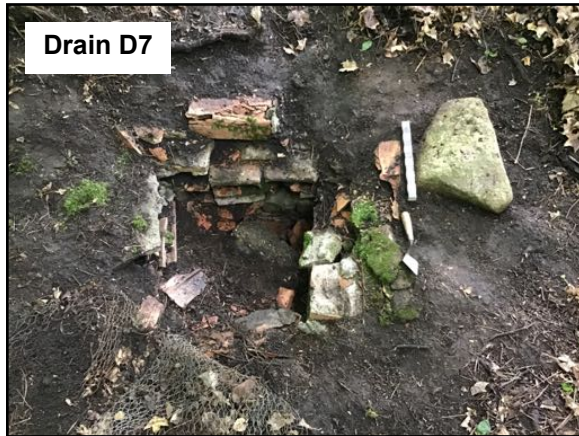
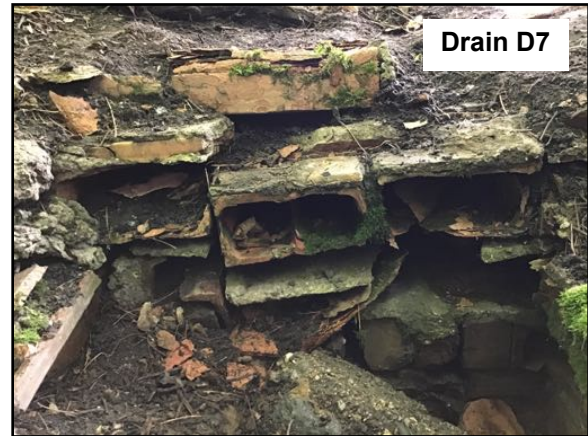
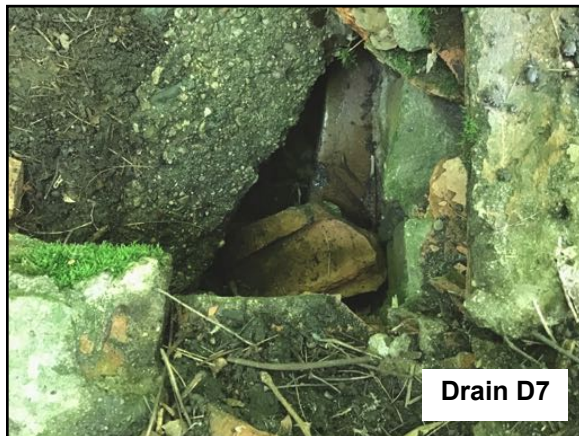
D7: Drain

Five drains and 1 slew have been identified in the project area. Drain D11 is an interesting example of water management for the Restaurant. MHM thoroughly documented the terra cotta tile, concrete, and metal, feature, including 3D scanning. Another water management tool assisted D7 in taking water away from the Restaurant; a slew (D8) was located up-hill from D7 and fed waste water toward the drain.

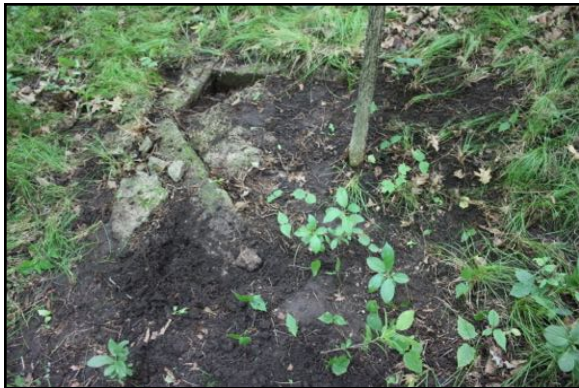
MHM identified an unaltered, sturdy, and sealed feature - Sealed Infrastructure -located on a high spot in the project area near the Amusements Building. MHM suspects the feature was part of the electrical system of the BIAP. MHM recorded the feature, took photographs, and 3D scanned the Sealed Infrastructure

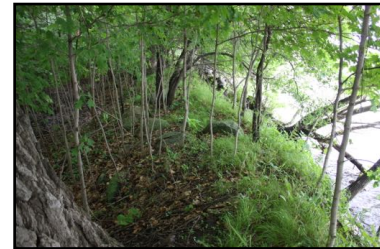
An obvious and large human-made BIAP Berm and RipRap combination was identified on the northeast end of the project area.

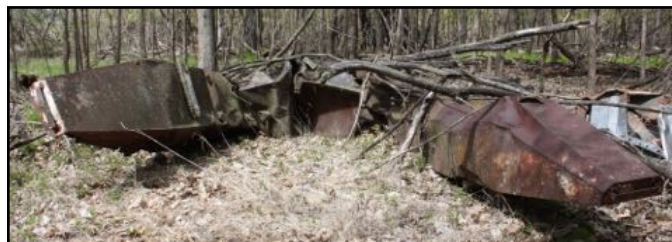
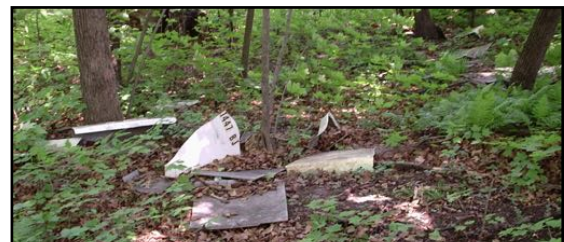
Boats

The remains of 2 boats are located on the east side of the project area. Two large metal pontoons with associated galley equipment (oven, stove, many burner covers) are located near the Roller Coaster. To the east of the Swamp Watching Platform, pieces of a cut-up fiberglass boat are spread around the area. One of the pieces is the starboard bow and its registration number survives: MN 1447 BJ. MHM's DNR contact provided the vital statistics for the boat and she was a 1959 Seaflite 16.00' fiberglass vessel, and her last registration expired in December 1981 (John Nordby, personal communication, August 2019). A third boat was on the island 10 years ago, in the swampy area at the western end of the project area. The metal boat was probably moved off the island, but there is a slight chance that it sank into the swamp.
